Clare Coastal Architectural Survey 2007/08 – Killkee

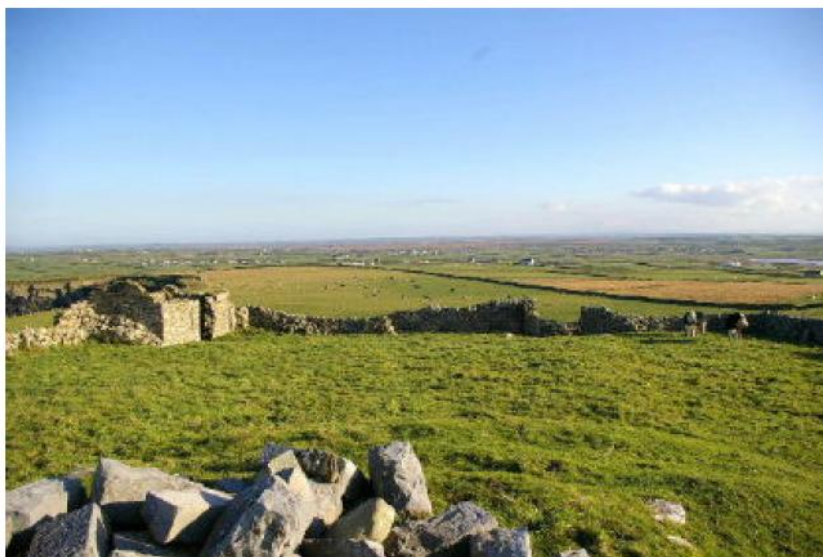
Registration number	CS054		
Location	Map Information		
<i>Name</i>		<i>County Code</i>	Clare
<i>Number</i>		<i>Map Type</i>	6 inch
<i>Street Name</i>		<i>Map Sheet</i>	046
<i>Town</i>		<i>NGR</i>	90964, 165873
<i>Townland</i>	Ballard		
Classification			
<i>Original type</i>	Signal Tower		
<i>In Use As</i>	Now Demolished, remains of barracks & boundary walls still <i>in situ</i>		
<i>Additional Use</i>			
<i>Historical Use</i>			
<i>Date</i>	1800-1820		
Categories of Special Interest		Historical & Technical	
<i>Condition</i>	In Ruins	<i>Rating</i>	Regional
Summary Description			
<p>'Remains of detached rubble stone fort, <i>circa</i> 1810, on a rectangular plan; ruinous. Remains of detached three-bay single-storey cottage, <i>circa</i> 1810; ruinous. Rubble stone built boundary walls' (NIAH, 2000). Enclosing boundary walls survive up to 2m in height. A mound of cut limestone in centre of enclosure marks the location of the former signal tower which was demolished in the 1960s the footings of the former tower are still visible. The tower, boundary walls and cottage were all built from the local thin-bedded Namurian sandstone with the limestone used for sills and other dressings. Assigned local rating by NIAH and marked signal tower on first edition 1842 O.S. map. This site is also an RMP site (CL046-005) as it was incorrectly believed to be the site of a medieval castle. Signal tower, barracks building and boundary walls are shown on first edition (1842) O.S. map. Complex is named <i>Telegraph Station</i>. The complex is marked <i>Baltard Tower (in Ruins)</i> on the 1915 revised edition O.S. map.</p>

Appraisal			
Remains of this signal tower complex is a reminder of the Napoleonic era when such structures/complexes were erected around the British and Irish coastline to resist the threat of French invasion. In subsequent years these structures were often utilised as coastguard station.			
<i>RMP</i>	CL046-005	<i>RPS</i>	341
<i>Inspected By</i>	S. Halpin	<i>Date of Inspection</i>	11.07.06

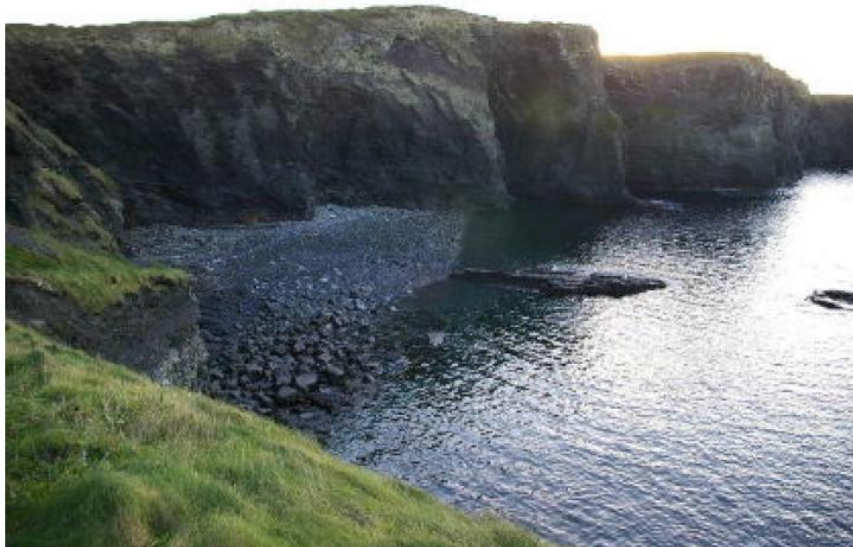
Registration number	CS055		
Location			Map Information
<i>Name</i>	Bealnalincka	<i>County Code</i>	Clare
<i>Name 2</i>	Locally known as the Hubawns	<i>Map Type</i>	6 inch
<i>Street Name</i>		<i>Map Sheet</i>	046
<i>Town</i>		<i>NGR</i>	90413, 165116
<i>Townland</i>	Ballard		
Classification			
<i>Original type</i>	Landing Place		
<i>In Use As</i>	No longer in use		
<i>Additional Use</i>			
<i>Historical Use</i>			
<i>Date</i>	1880-1920		
Categories of Special Interest	Cultural, Historical & Technical		
<i>Condition</i>	Poor	<i>Rating</i>	Local
Summary Description			
<p>Landing place marked on the 1915 O.S. revision, but possibly earlier in date. Situated on rocky shore surrounded by high cliffs, it was once accessed via a narrow trackway along cliff edge which is now blocked due to small landslide. No structural remains can be discerned, however two lengths of outcropping rock can be distinguished. According to local information the landing place was built up around the section of outcropping stone and has been disused for some time. It is visible when the tide goes out. The bay is locally known as 'Hubawns Bay' and was locally used for fishing and swimming.</p>

Appraisal			
<p>This former landing place is located in a deep natural harbour surrounded by high cliffs. It appears to be no longer used due to difficulty of access. It attests to a time when fishing and smuggling were an intrinsic part of the local economy. This period is long since gone and these former landing place act as a reminder of a way of life now consigned to local folklore.</p>			
<i>RMP</i>		<i>RPS</i>	
<i>Inspected By</i>	S. Halpin	<i>Date of Inspection</i>	02.11.06

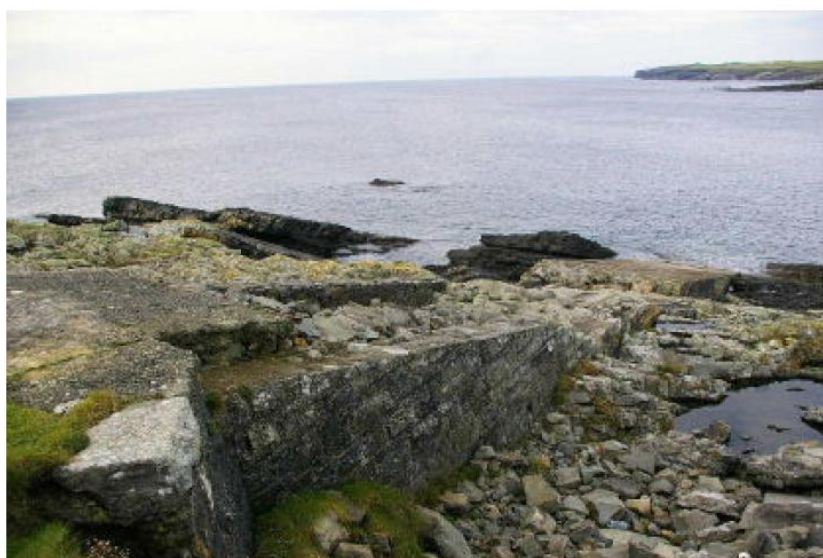
Registration number	CS056		
Location			Map Information
<i>Name</i>		<i>County Code</i>	Clare
<i>Number</i>		<i>Map Type</i>	6 inch
<i>Street Name</i>		<i>Map Sheet</i>	046
<i>Town</i>		<i>NGR</i>	90643, 163814
<i>Townland</i>	Farrihy		
Classification			
<i>Original type</i>	Slipway		
<i>In Use As</i>	No longer in use		
<i>Additional Use</i>			
<i>Historical Use</i>			
<i>Date</i>	1880-1920		
Categories of Special Interest	Architectural & Technical		
<i>Condition</i>	Poor	<i>Rating</i>	Local
Summary Description	Slipway, built <i>circa</i> 1900, extending steeply from rocky shoreline down to sea on south side of Farrihy Bay. Comprising finely built sidewalls of coursed rock-faced sandstone which display a battered base. Section of north face of wall largely concrete rendered. Inner face of walls composed of uncoursed random rubble. Remains of lime and later concrete pointing survive in places. The walkway is infilled with rubble made up of the local sandstone which has the remains of a concrete rendered walkway. Walkway is largely eroded away. Sidewalls measure approximately 0.60m thick. Slipway itself measures 4.9m wide by approximately 40m long.

Appraisal	This slipway is located in a visually stunning location overlooking Farrihy Bay. The seashore in this area is comprised of exposed beds of sandstone rising at an angle from the ground. This stone probably provided the building stone for the slipway.		
<i>RMP</i>		<i>RPS</i>	
<i>Inspected By</i>	S. Halpin	<i>Date of Inspection</i>	18.10.06

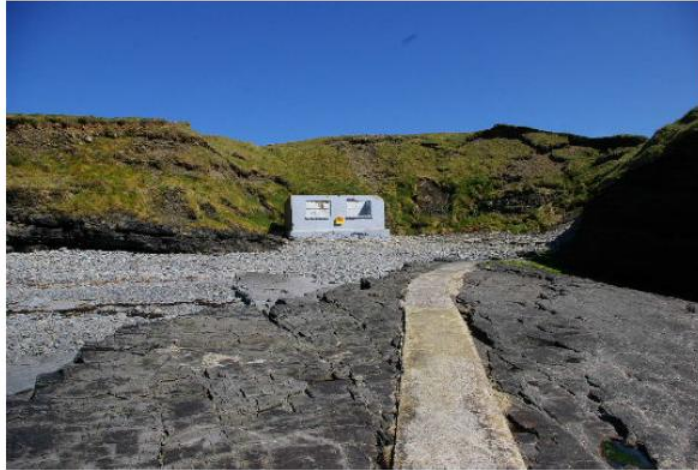
Registration number	CS057		
Location			Map Information
<i>Name</i>	Byrne's Cove	<i>County Code</i>	Clare
<i>Number</i>		<i>Map Type</i>	6 inch
<i>Street Name</i>		<i>Map Sheet</i>	056
<i>Town</i>	Kilkee	<i>NGR</i>	88184, 161362
<i>Townland</i>	Corbally		
Classification			
<i>Original type</i>	Sea baths		
<i>In Use As</i>	No longer in use		
<i>Additional Use</i>			
<i>Historical Use</i>			
<i>Date</i>	1940-1980		
Categories of Special Interest		Architectural & Technical	
<i>Condition</i>	In Ruins	<i>Rating</i>	Local
Summary Description			
Detached single-storey two-bay former bathing shelter/changing room, built c.1960, now in ruins, overlooking Byrnes Cove. Originally with flat roof, now gone, concrete rendered walls, concrete plinth and sill. Situated overlooking rocky inlet 'Byrnes Cove' beneath St. Georges Head. Concrete steps give access to rocky shore and former changing room. A concrete path has been laid on a piece of protruding bedrock leading to the waters edge.

Appraisal			
This former bathing shelter/bathing area is testimony to the recreational and social development of Kilkee as a coastal resort.			
<i>RMP</i>		<i>RPS</i>	
<i>Inspected By</i>	S. Halpin	<i>Date of Inspection</i>	26.04.07

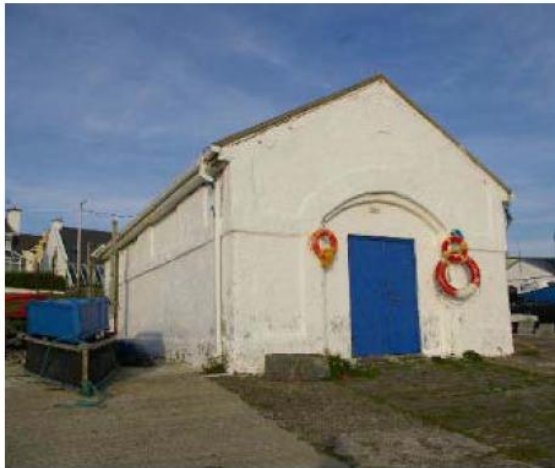
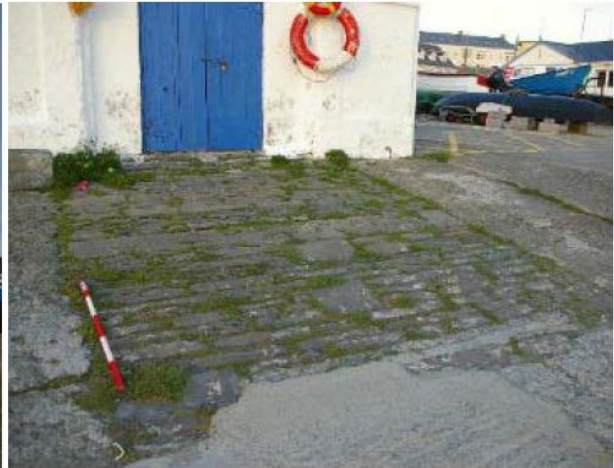
Registration number	CS058		
Location			Map Information
<i>Name</i>		<i>County Code</i>	Clare
<i>Number</i>		<i>Map Type</i>	6 inch
<i>Street Name</i>		<i>Map Sheet</i>	056
<i>Town</i>	Kilkee	<i>NGR</i>	88497, 160420
<i>Townland</i>	Dough		
Classification			
<i>Original type</i>	Boathouse		
<i>In Use As</i>	Boathouse		
<i>Additional Use</i>			
<i>Historical Use</i>			
<i>Date</i>			
Categories of Special Interest	Architectural, Cultural & Technical		
<i>Condition</i>	Good	<i>Rating</i>	Regional
Summary Description			
<p>'Detached single-bay, single-storey, gable-fronted boathouse, <i>circa</i> 1890, originally with segmental-headed door opening and four-bay side elevations; renovated <i>circa</i> 1940, opening remodelled to accommodate commercial use and use as store' (NIAH, 2000). Section of cobbling survives to front of boathouse. The cobbling is composed of the local Namurian sandstone laid in narrow horizontal strips. This may reflect the earlier surface of the slipway.</p>

Appraisal			
<p>This picturesque boathouse is sited adjacent to Kilkee pier and slipway overlooking Moore Bay and Kilkee seafront. The boathouse together with the associated slipway, pier and life boat building attest to the continuing importance of maritime activities in the area.</p>			
<i>RMP</i>		<i>RPS</i>	511
<i>Inspected By</i>	S. Halpin	<i>Date of Inspection</i>	02.11.06

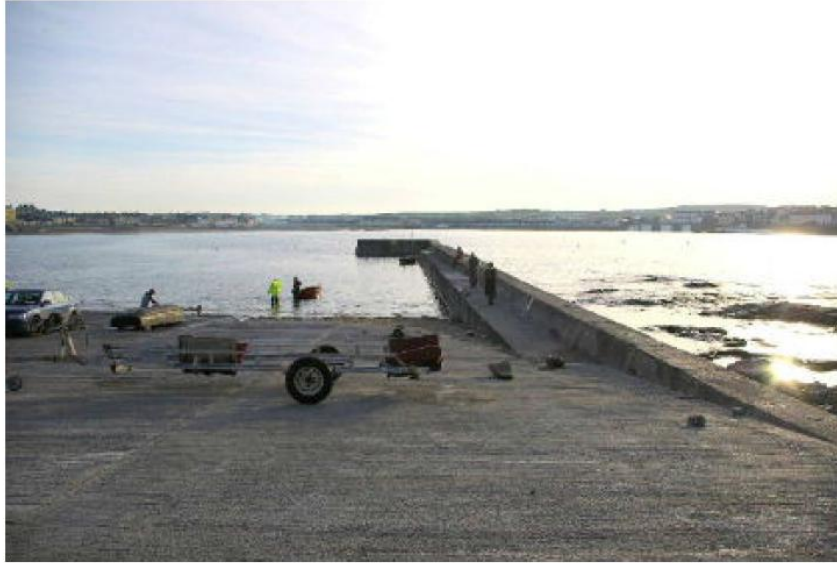
Registration number	CS059		
Location		Map Information	
<i>Name</i>		<i>County Code</i>	Clare
<i>Number</i>		<i>Map Type</i>	6 inch
<i>Street Name</i>		<i>Map Sheet</i>	056
<i>Town</i>	Kilkee	<i>NGR</i>	88458, 160380
<i>Townland</i>	Dough		
Classification			
<i>Original type</i>	Pier & Slipway		
<i>In Use As</i>	Pier & Slipway		
<i>Additional Use</i>			
<i>Historical Use</i>			
<i>Date</i>	1885-1890		
Categories of Special Interest		Technical	
<i>Condition</i>	Good	<i>Rating</i>	Local
Summary Description			
<p>Concrete L-shaped pier, originally constructed <i>circa</i> 1887, on north side of Moore Bay, with later repairs and possible extensions evident. Concrete rendered walls with battered base with steps to south end. End of pier accessed via a narrow pedestrian pathway. Concrete slipway to east side of pier. The slipway and pier was most likely constructed with the local stone and paved with cobbles. There is no surviving visible remains of stone pier today, it is all probably encased in concrete. A slipway and breakwater are shown on the 1915 revised O.S. map leading down from the boathouse to the shore</p>

Appraisal			
<p>No remains of the original pier are visible today. There is very little of architectural note surviving however the present mass concrete repair/extension does have some technical and engineering significance.</p>			
<i>RMP</i>		<i>RPS</i>	
<i>Inspected By</i>	S. Halpin	<i>Date of Inspection</i>	03.11.06

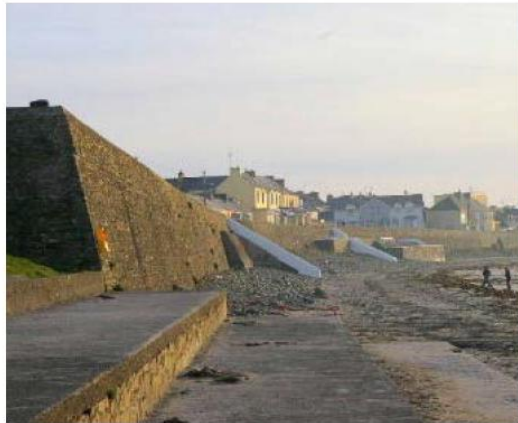
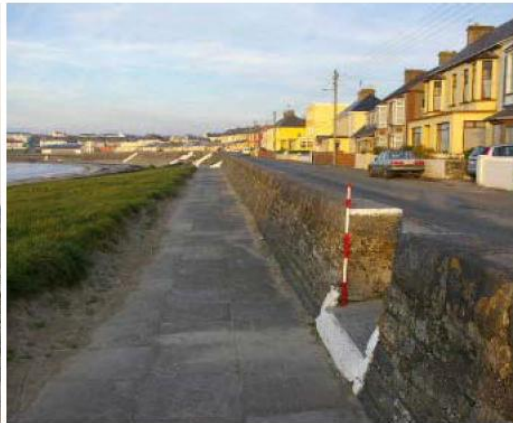
Registration number	CS060		
Location			Map Information
<i>Street Name</i>	Strand Line, Victoria Place, Marine Parade, Clifton Terrace, MacDonald Terrace	<i>Map Sheet</i>	056
<i>Town</i>	Kilkee	<i>NGR</i>	88598, 160012
<i>Townland</i>	Dough		
Classification			
<i>Original type</i>	Sea Wall & Promenade		
<i>In Use As</i>	Sea Wall & Promenade		
<i>Additional Use</i>			
<i>Historical Use</i>			
<i>Date</i>	1820-1840		
Categories of Special Interest	Architectural, Historical, Social & Technical		
<i>Condition</i>	Good	<i>Rating</i>	Regional
Summary Description			
<p>Stone built seawall of local thin bedded sandstone built largely in 19th century with later sections of repair evident. 'The sea wall and embankment around the bay was begun on the west side as part of famine relief work in 1846 and completed in the 1860's. The wall was badly damaged in 1886 and again in 1951' (Clare Library website: www.clarelibrary.ie). Walls are constructed from roughly coursed cut sandstone blocks. There are a number of details of skilled stone work. A now blocked arched opening at the northern end of the wall displays cut stone voissiors and there is a section of rock-faced cut sandstone walls near the slipway (CS061) with a flight of inset cut sandstone steps nearby (just below Wellington Square). The wall to the road appears to be later than the sea wall and is constructed from uncoursed rubble stone with large sandstone blocks laid as coping. During the 20th century much of the central section of the seawall was added to, forming a promenade and green spaces. This later section also displays rubble stone walls with a base batter. This later section contains a viewing area, the lifeguard hut (CS059) and bandstand (CS060).</p>

Appraisal			
<p>This impressive seawall is of historic and technical interest. It was begun on the west side as a famine relief scheme and is testimony to the skills of the local community at that time. It is largely intact and later developments such as the promenade have largely respected it. It adds textural variation to the promenade and enhances the coastal setting. The later promenade is in continuous use for the purpose for which it was originally intended.</p>			
<i>RMP</i>		<i>RPS</i>	
<i>Inspected By</i>	S. Halpin	<i>Date of Inspection</i>	03.11.06

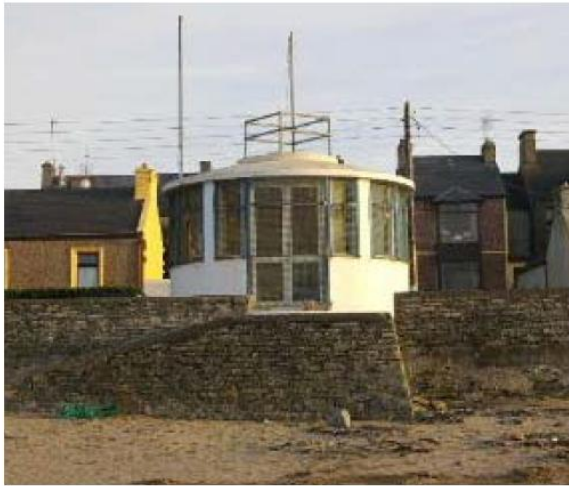
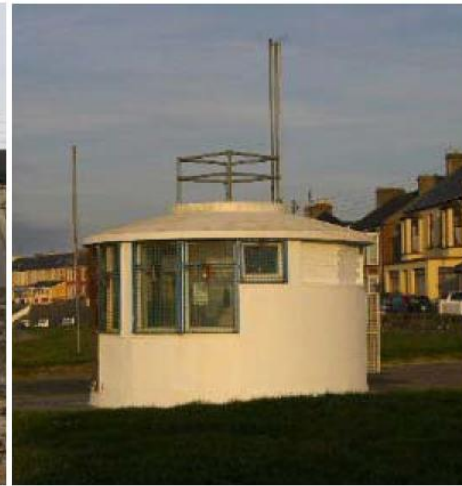
Registration number	CS061		
Location		Map Information	
<i>Name</i>		<i>County Code</i>	Clare
<i>Number</i>		<i>Map Type</i>	6 inch
<i>Street Name</i>	Strand Line	<i>Map Sheet</i>	056
<i>Town</i>	Kilkee	<i>NGR</i>	88471, 159868
<i>Townland</i>	Dough		
Classification			
<i>Original type</i>	Life Guard Hut		
<i>In Use As</i>	Life Guard Hut		
<i>Additional Use</i>			
<i>Historical Use</i>			
<i>Date</i>	1940-1980		
Categories of Special Interest		Cultural & Social	
<i>Condition</i>	Good	<i>Rating</i>	Local
Summary Description			
Circular in plan, freestanding, three-bay concrete life-guard post, built <i>circa</i> 1960, overlooking Moore Bay. Rendered domed roof with rendered circular cap surmounted by aluminium railing and flagpole. Rendered walls with square-headed openings with replacement Upvc windows and double door all with security shutters. Circular plan former bathing shelter/changing area located immediately to the southwest, now in use as storage hut.

Appraisal			
This life guard hut and changing area is indicative of the functional seaside architecture of this period. The building is still used for its original purpose.			
<i>RMP</i>		<i>RPS</i>	
<i>Inspected By</i>	S. Halpin	<i>Date of Inspection</i>	03.11.06

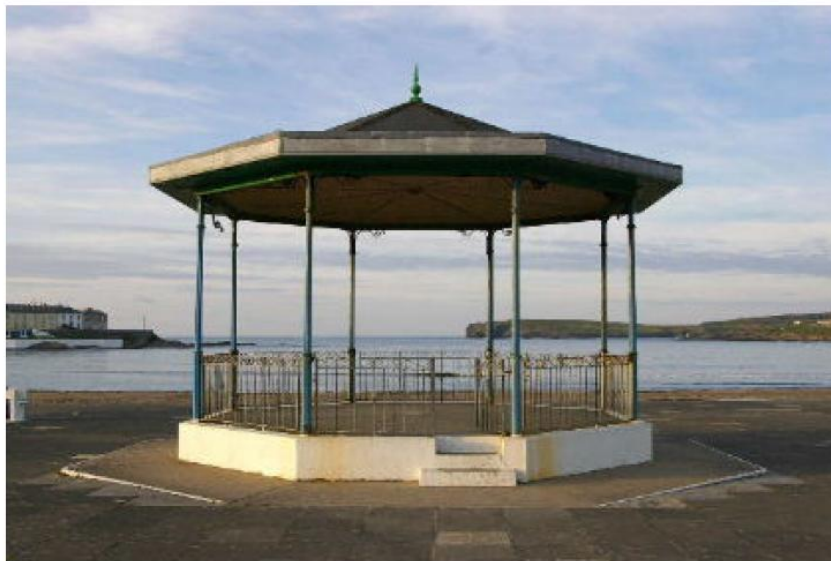
Registration number	CS062		
Location			Map Information
<i>Name</i>		<i>County Code</i>	Clare
<i>Number</i>		<i>Map Type</i>	6 inch
<i>Street Name</i>	Victoria Place	<i>Map Sheet</i>	056
<i>Town</i>	Kilkee	<i>NGR</i>	88353, 159772
<i>Townland</i>	Dough		
Classification			
<i>Original type</i>	Bandstand/Pavilion		
<i>In Use As</i>	Bandstand/Pavilion		
<i>Additional Use</i>			
<i>Historical Use</i>			
<i>Date</i>	1920-1960		
Categories of Special Interest	Architectural, Social & Technical		
<i>Condition</i>	Fair	<i>Rating</i>	Local
Summary Description			
<p>Octagonal in plan, freestanding bandstand, built <i>circa</i> 1940. Felted octagonal roof capped with a cast-iron spike. Overhanging eaves with timber battened lining to underside. Roof supported by eight tapered and fluted cast-iron pillars with only a small number of its decorative brackets still <i>in situ</i>. Replacement aluminium railing and concrete base.</p>

Appraisal			
<p>This former bandstand although in need of some repair is still of architectural and technical merit. It is also of social and cultural interest reflecting the pastimes and entertainment of this seaside resort.</p>			
<i>RMP</i>		<i>RPS</i>	
<i>Inspected By</i>	S. Halpin	<i>Date of Inspection</i>	03.11.06

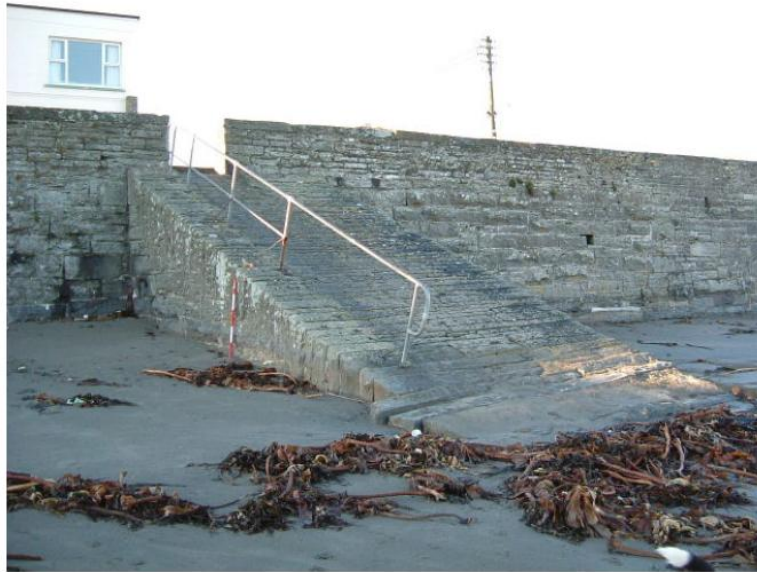
Registration number	CS063		
Location	Map Information		
<i>Name</i>		<i>County Code</i>	Clare
<i>Number</i>		<i>Map Type</i>	6 inch
<i>Street Name</i>	Marine Parade	<i>Map Sheet</i>	056
<i>Town</i>	Kilkee	<i>NGR</i>	88095, 159874
<i>Townland</i>	Kilkee Upper		
Classification			
<i>Original type</i>	Slipway		
<i>In Use As</i>	Slipway		
<i>Additional Use</i>			
<i>Historical Use</i>			
<i>Date</i>	1880-1920		
Categories of Special Interest		Architectural, Social & Technical	
<i>Condition</i>	Good	<i>Rating</i>	Local
Summary Description			
<p>Stone slipway, built <i>circa</i> 1900, leading steeply from roadside down to beach. Constructed from local thin-bedded sandstone with sidewalls of coursed rock-faced sandstone blocks with kerbstones comprised of long narrow upright sections also rock-faced. Cobbling still intact to surface consists of narrow lengths of worn sandstone. Some later concrete pointing visible in places. A modern aluminium railing is fitted on one side of the slipway. The slipway is flanked on either side by the sea wall, which also displays rock-facing. This slipway is not marked on the first edition (1842) O.S. map. It is marked <i>Slip</i> on the revised 1915 O.S. map.</p>

Appraisal			
<p>This stone slipway displays expert craftsmanship in its construction and is testimony to the men who constructed it. It is still in use and is in good condition.</p>			
<i>RMP</i>		<i>RPS</i>	
<i>Inspected By</i>	S. Halpin	<i>Date of Inspection</i>	03.11.06

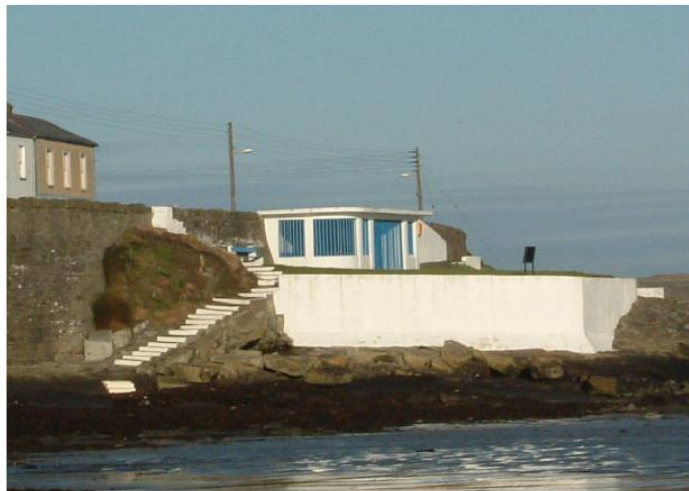
Registration number	CS064		
Location		Map Information	
<i>Name</i>		<i>County Code</i>	Clare
<i>Number</i>		<i>Map Type</i>	6 inch
<i>Street Name</i>	Clifton Terrace	<i>Map Sheet</i>	056
<i>Town</i>	Kilkee	<i>NGR</i>	88108, 160034
<i>Townland</i>	Kilkee Upper		
Classification			
<i>Original type</i>	Sea Baths		
<i>In Use As</i>	Sea Baths		
<i>Additional Use</i>			
<i>Historical Use</i>			
<i>Date</i>	1940-1980		
Categories of Special Interest		Architectural, Social & Cultural	
<i>Condition</i>	Good	<i>Rating</i>	Local
Summary Description			
<p>Flat-roofed, four-bay, single-storey concrete bathing shelter/changing room, built <i>circa</i> 1960, situated at the West End, overlooking Moore Bay. Built abutting sea wall. Flat roof with overhanging eaves with rounded corners. Rendered walls with rounded corners with square-headed openings now locked with security grills for until summer season. Set in green space with two sets of concrete steps leading to waters edge for swimmers. Accessed from road via stone stiles and cut stone steps with later wheel chair ramp also providing access.</p>

Appraisal			
<p>This bathing area probably has a long tradition of use predating the construction of the changing facility, as evidenced by the cut stone stile and associated stone steps. It is testimony to the recreational and social development of the town as a coastal resort.</p>			
<i>RMP</i>		<i>RPS</i>	
<i>Inspected By</i>	S. Halpin	<i>Date of Inspection</i>	03.11.06

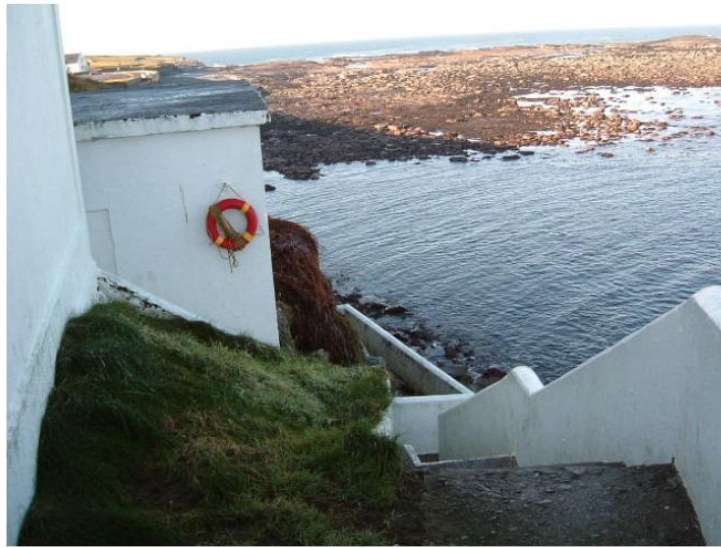
Registration number	CS065		
Location			Map Information
<i>Name</i>		<i>County Code</i>	Clare
<i>Number</i>		<i>Map Type</i>	6 inch
<i>Street Name</i>	MacDonald Terrace	<i>Map Sheet</i>	056
<i>Town</i>	Kilkee	<i>NGR</i>	87777, 160224
<i>Townland</i>	Kilkee Upper		
Classification			
<i>Original type</i>	Sea Baths		
<i>In Use As</i>	Sea Baths		
<i>Additional Use</i>			
<i>Historical Use</i>			
<i>Date</i>	1940-1980		
Categories of Special Interest		Social	
<i>Condition</i>	Poor-Fair	<i>Rating</i>	Local
Summary Description			
<p>Bathing area comprising two flat-roofed rectangular in plan, former changing room, built <i>circa</i> 1960, now boarded up. Concrete steps lead down to the rocky shoreline and display rendered side walls. Area is accessed from a small opening in the wall on MacDonald Terrace and a small flight of cut stone steps which lead to former changing facilities and later concrete steps.</p>

Appraisal			
<p>Although the changing rooms are boarded up, this bathing area is still maintained. Like CS063 and the nearby Pollock Holes it probably has a long tradition of use predating the construction of the changing facility, as evidenced by stone steps leading down from opening in wall on MacDonald Terrace. It is testimony to the recreational and social development of the town as a coastal resort.</p>			
<i>RMP</i>		<i>RPS</i>	
<i>Inspected By</i>	S. Halpin	<i>Date of Inspection</i>	03.11.06

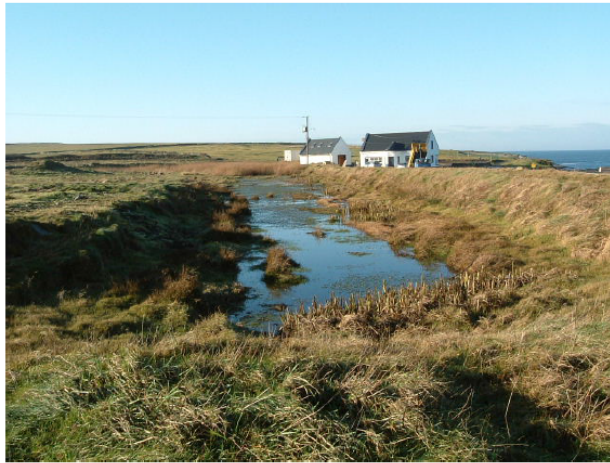
Registration number	CS066		
Location			Map Information
<i>Name</i>		<i>County Code</i>	Clare
<i>Number</i>		<i>Map Type</i>	6 inch
<i>Street Name</i>		<i>Map Sheet</i>	056
<i>Town</i>	Kilkee	<i>NGR</i>	87519, 160185
<i>Townland</i>	Kilkee Upper		
Classification			
<i>Original type</i>	Fish Pond		
<i>In Use As</i>	No longer in use		
<i>Additional Use</i>			
<i>Historical Use</i>			
<i>Date</i>	Unknown, possibly 16 th – 17 th century		
Categories of Special Interest		Archaeological & Technical	
<i>Condition</i>	Poor	<i>Rating</i>	Regional
Summary Description			
<p>According to Westropp this was known as ‘Lady Isabella’s Fishpond’, ‘her date and surname unknown – some say she was an O’Brien’. Westropp describes the site as a ‘complex (earthwork) and of unusual interest. At the foot of a long slope, close to the end of the great natural breakwater of Duggerna, we can see a large oblong space, fenced by high mounds and fed by streams, which, in my recollection, have greatly diminished in volume. The banks area well made, 5 to 6 feet high, the north is almost exactly 300 feet long and the south about 340 to 350 feet, being hard to define and broken by the mouth and streamlet. The actual basin is still full of water and forests of tall yellow iris. It is from 21 to 24 feet wide, and has a low offset to the south, which was overflowed when the reservoir was quite full. The feeding drains and the group of house sites connected with it are curious. The south mound has been much dug away... The whole work measures about 300 to 350 feet east and west by 110 feet north and south’. Leo Morahan, from the Archaeological Survey of Ireland visited the site in 2003 and describes it as follows ‘Site consist of a well preserved fish pond whose interior still retains a certain amount of water... the reservoir of the fish pond is enclosed by a 130m long bank of earth along the northern sector’ (RMP Archives). Site is not marked on first edition (1842) O.S. map. Marked <i>Fish Pond</i> on the 1915-1918 O.S. map.</p>

Appraisal			
This site is of archaeological and technical significance and is a unique example of a fish pond in the archaeological inventory of County Clare.			
<i>RMP</i>	CL056-035	<i>RPS</i>	
<i>Inspected By</i>	S. Halpin	<i>Date of Inspection</i>	03.11.06
